Service Bulletin

Subject: McDonald's New Preheat Gap Setting
To: Factory Authorized Service Agencies US & Canada
Product: Garland Clamshell Models ME & MG
Date: April 05, 2018

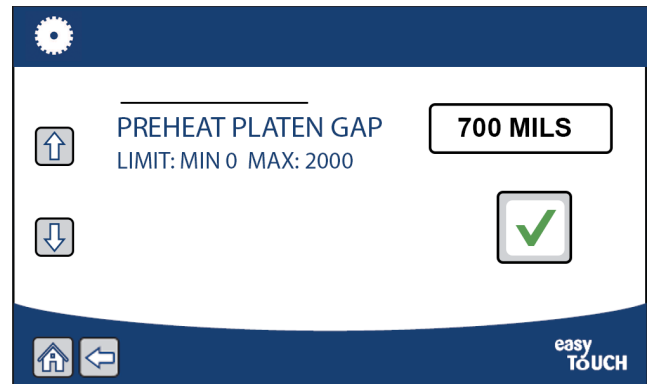
There have been reports of the upper platen coming down for preheating from AM to PM with the utensils (egg ring set) on the grill causing damage to the platen arm. In order to prevent this from happening the preheating gap between the grill plate and the platen will be increased.

5. Key in the new gap dimension of 700 MILS then press "✓" checkmark to enter or X to cancel.

6. Ensure the number changed to 700 MILS. Press the checkmark to continue.
