Service Bulletin

Subject: Clamshell Grill ATX Conduit and Access Hatch Change

Brand/Product: Next Gen Grills

Date: 5th June 2020

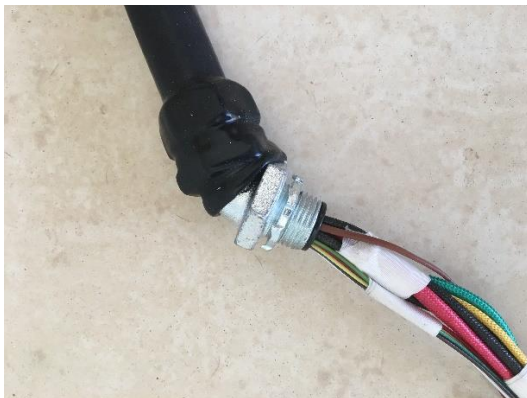
CK4600726 Up to April 2019

Old Conduit design (Installed on units up to and including April 2019 Serial 19041001XXXXX)

Use a 45-degree angle fitting to connect to the top of the platen cowl access hatch. This is then secured by a lock nut on the other side of the cowl cover.

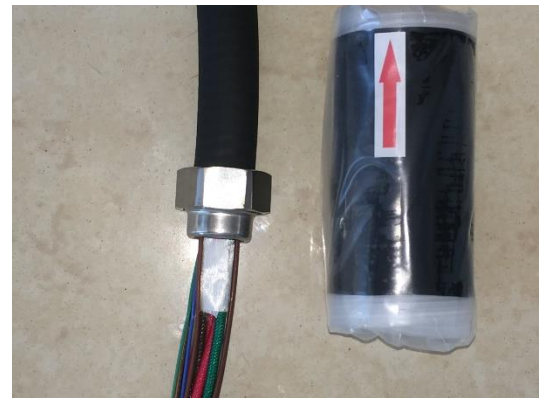
CK4603291 From May 2019

New Conduit design (Installed on units from May 2019 Serial 19051001XXXXX)

The new ATX Conduit has a single straight nut. The nut will screw directly to the cowl access hatch. The new cowl access hatch is designed so that it has a 20-degree raised threaded section moulded into the casting for allowing tightening to the conduit nut. This reduces the number of potential entry points of any liquid to the platen cowl and reduces the entry angle of the conduit. It also relieves some stress at the joint. The new conduit should be used on grills built from 19051001XXXXX, it will also be the fitting needed if you are replacing the grill cowl or platen assembly. If you are ordering a platen assembly for a unit Pre 19051001XXXXX, order it with the conduit to avoid any compatibility issues.

When you receive a new design conduit (CK4603291), you will also receive a separate cold shrink sleeve, this will need to be fitted once the conduit has been fitted into the access hatch. The cold shrink sleeve will allow you to tighten the conduit nut to the access the hatch cover. This would not be possible if the cold shrink is pre-fitted.

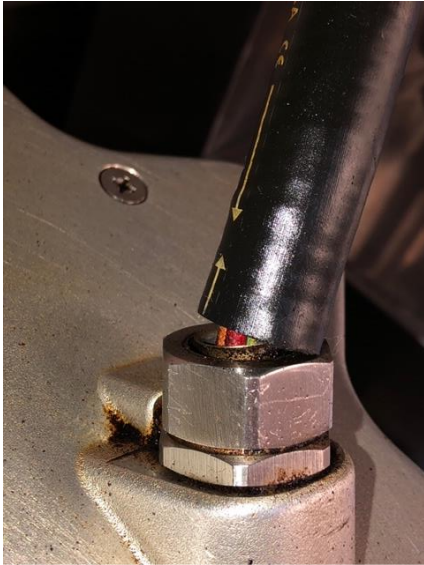
Not Covered by Warranty

Garland will continue to cover damage to the outer covering if repaired with a cold shrink (see bulletin MCD-08-19-ACI 11/19), which should be used if the damaged area is 2" or less (50mm). Failures to the steel inner section as shown in picture will not be covered by warranty as these are caused by excessive strain being placed on the conduit from external forces

That if the conduit inner steel is damaged the claim will be rejected. Claims that are submitted without a picture showing the damage of the old conduit will also be rejected.

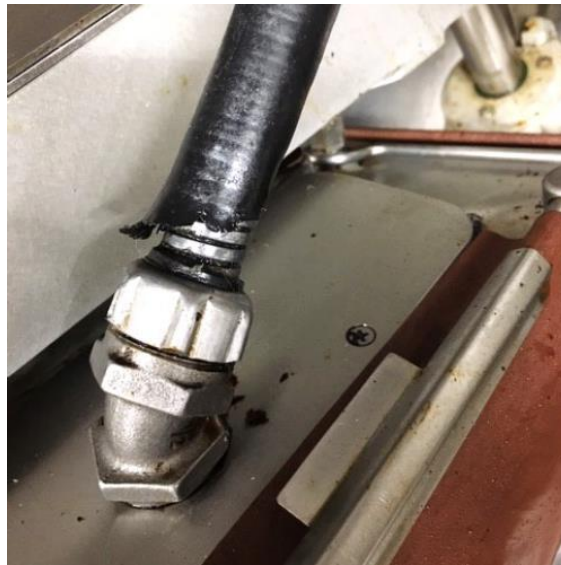
Covered by Warranty

Garland has found that the conduit outer sleeve is deteriorating. Until now, the only possible repair has been to replace the entire conduit which is an unnecessary, time consuming and costly repair. To overcome this, we have developed a field repair that can be easily fitted to resolve the issue of the outer sleeve splitting and thus avoid the need to replace the full conduit assembly. Moving forward this should be the repair used in the field.

Summary to Bulletin MCD-08-19-ACI 11/19**Conduit field repair kit CK4604306**
