Service Bulletin

Subject: XP E/G & M E/G Grill UI

UI Controller Compatibility Support

Document Number: CS-08-21-ACI 08/21

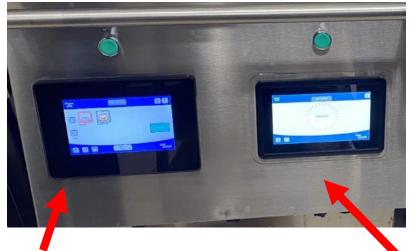
Side By side of the old and new controller

Existing HRCB+ controller (Ultratroniks)

New Common Controller (Jabil/ Merco Ultratroniks)

Note. The HRCB+ Ultratroniks UI is physically different in size so cannot be used to replace any Jabil controller
