Service Bulletin

Subject: Clamshell Conduit Field Repair (Cold Shrink)

Conduit field repair kit CK4604306

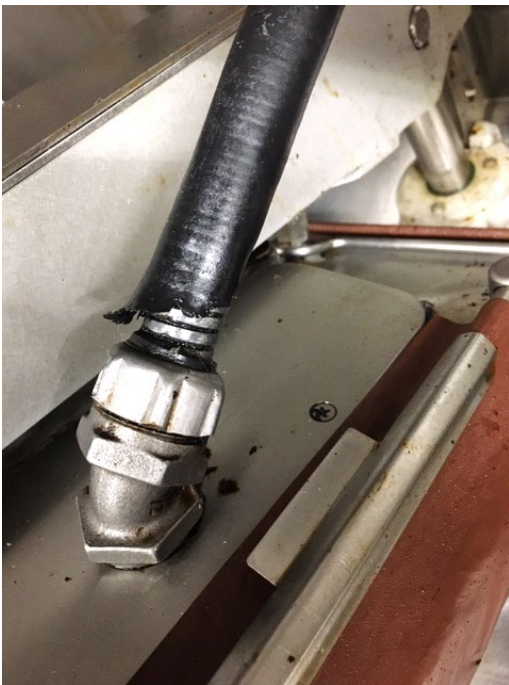
Garland has found that the conduit outer sleeve is deteriorating. Until now, the only possible repair has been to replace the entire conduit which is an unnecessary, time consuming and costly repair. To overcome this, we have developed a field repair that can be easily fitted to resolve the issue of the outer sleeve splitting and thus avoid the need to replace the full conduit assembly. Moving forward this should be the repair used in the field.

This is the scenario when the kit should be used and what it has been designed to repair (pictured below).

Damaged Conduit

The sleeve can be installed on the conduit when the outer sleeve is damaged. It is not designed to repair the conduit when the inner steel tube has been damaged. If the inner steel of the conduit has been damaged or has snapped, then the complete conduit assembly must be replaced.

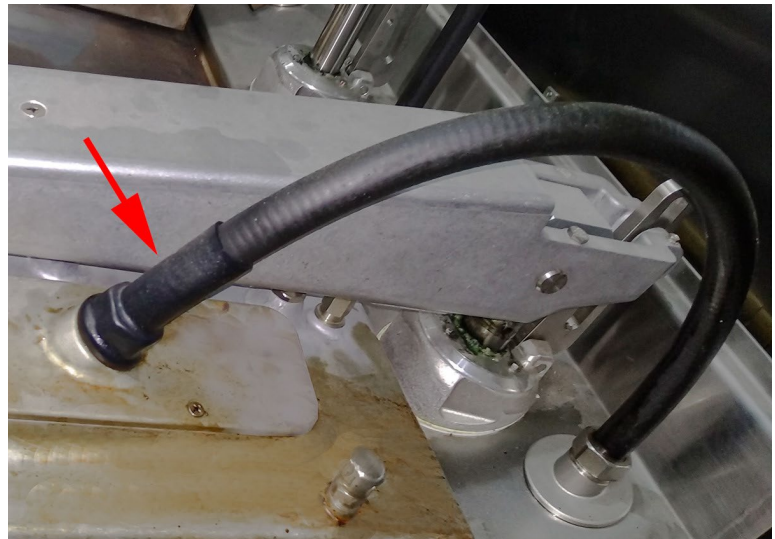
Repaired conduit

However, to be clear, even if there is no visible damage to the existing conduit outer sleeve, we are still recommending that this field repair kit be incorporated over the fitting and sleeve on the platen arm side. This will add another layer of protection for the unit and will help improve the service life of this part.

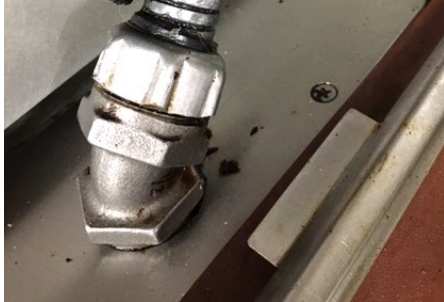
45-degree cowl connection (2 Cold Shrinks)

Fitting on arm – sleeve (fitting shown below)
Fitting on grill base – sleeve (not shown)

When installing the sleeve on to the conduit, we recommend sleeving the conduit on both ends if the platen cowl connection is at 45 degrees. If the platen cowl connection is at a 20 degree angle then the other end of the conduit does NOT have to be sleeved, so only the connection on the arm side of the conduit requires a sleeve.

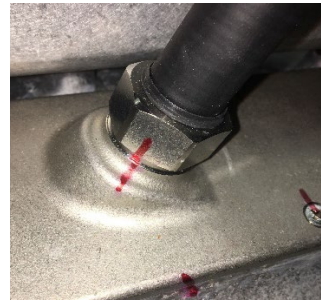
20-degree connection (1 cold shrink)

Fitting on arm – sleeve (fitting shown below)
Fitting on grill base – do not sleeve (not shown)
